PROJECT: Midnite Mine Remediation**REPORT NO:** 2021-33**OWNER:** Newmont/Dawn Mining**OPERATOR:** Newmont/Dawn Mining**SUMMARY OF WORK ACTIVITIES OR EVENTS FOR THIS REPORTING PERIOD:**

This weekly report provides a summary of Midnite Mine Site (Site) remediation action (RA) construction activities, quality assurance (CQA), quality control (CQC) and engineering activities for the period November 5 - 11, 2021. The Site activities discussed in this weekly report include, but are not limited to: Site Health, Safety, and Security; Community Liaison, Project Meetings, Regulatory Oversight, Site Visitors; Site Mobilization; RA Activities; Project Documentation; and Site Inspections.

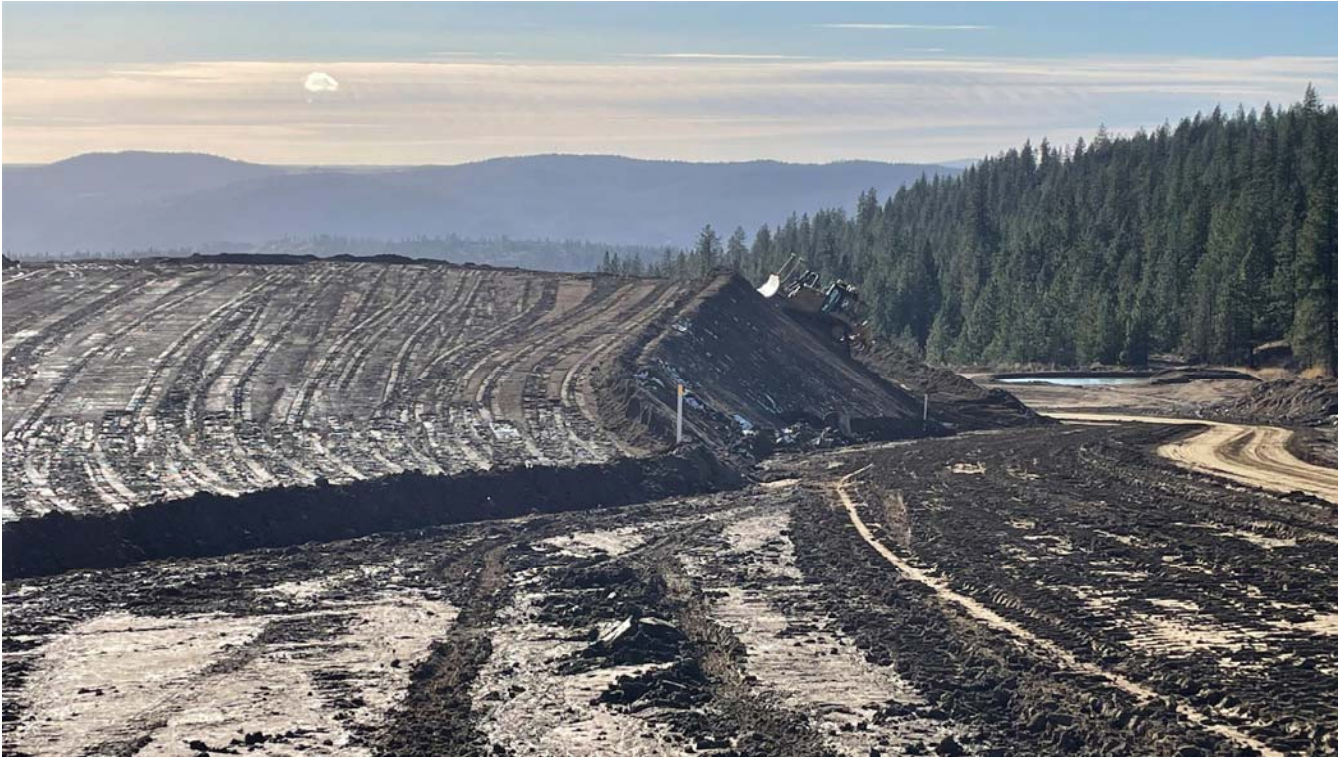
Figure 1 – Surface grading and track walking of Geomembrane Bedding stockpile as part of winter SWPPP preparation., view looking west.

- Newmont completed shaping the west side of the SWRP to flow to a collection sump where stormwater will be pumped to the South Pond.
- Newmont graded the Geomembrane Bedding stockpile to drain
- Newmont completed grading the crusher pad on the HSWRP to drain.

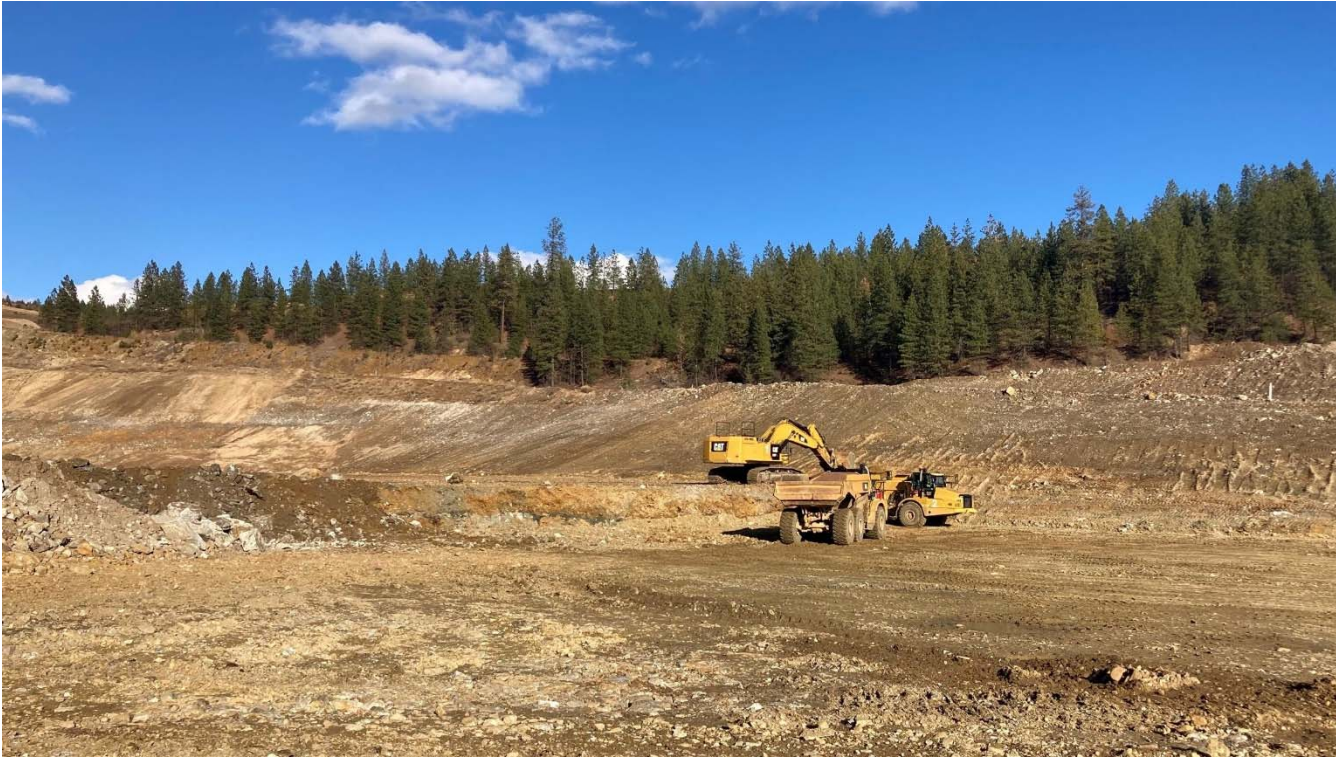
Figure 2 – Excavating, loading, and hauling low activity/low reactivity material from the SWRP to be used as fill at the Pit 4 dewatering risers, view looking northeast.

- Newmont excavated, hauled, and placed a small amount of low activity/low reactivity material from the west side of the South Waste Rock Pile (SWRP). Newmont placed the material around the risers in the Pit 4 Waste Containment Area (WCA) to build the area up for installation of the backup dewatering pumps in the Underdrain and Waste Rock Dewatering Sumps.

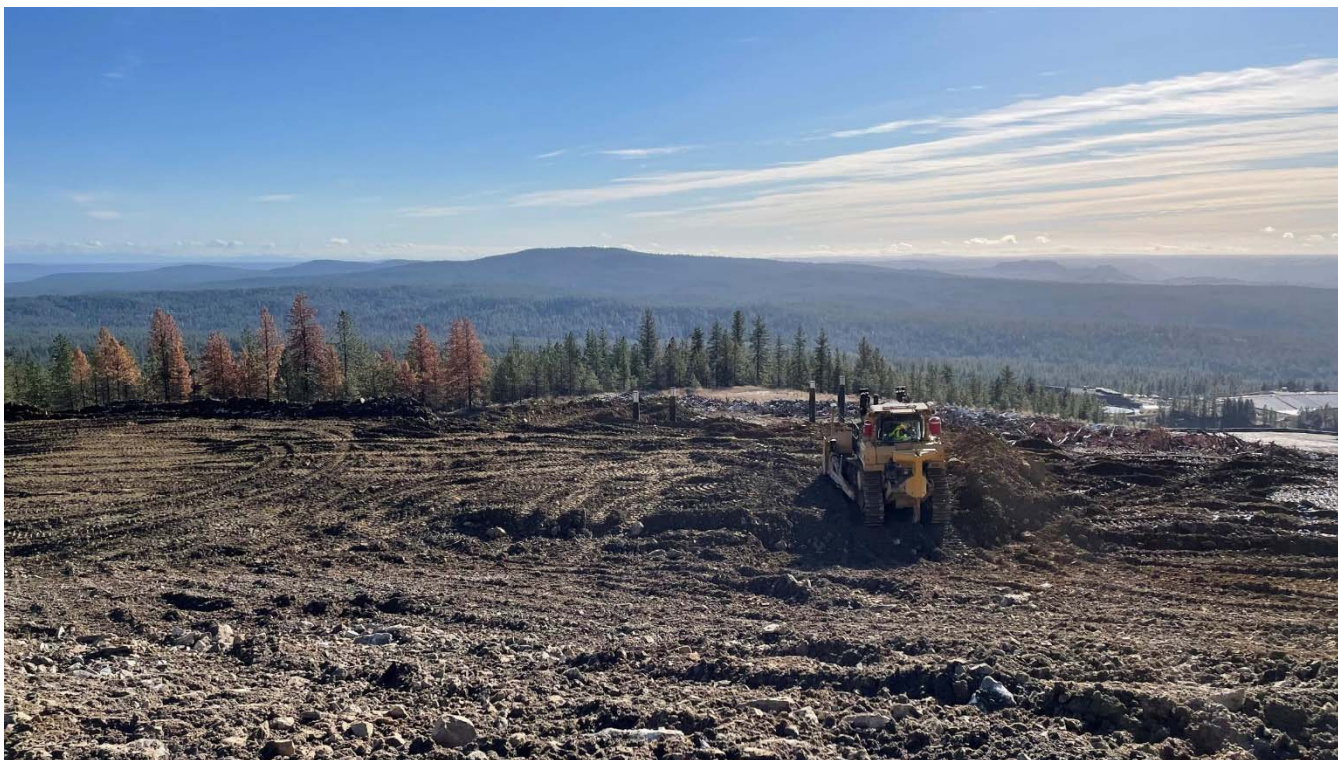
Figure 3 – Placing low activity/low reactivity material as fill around the Pit 4 dewatering risers, view looking southeast.

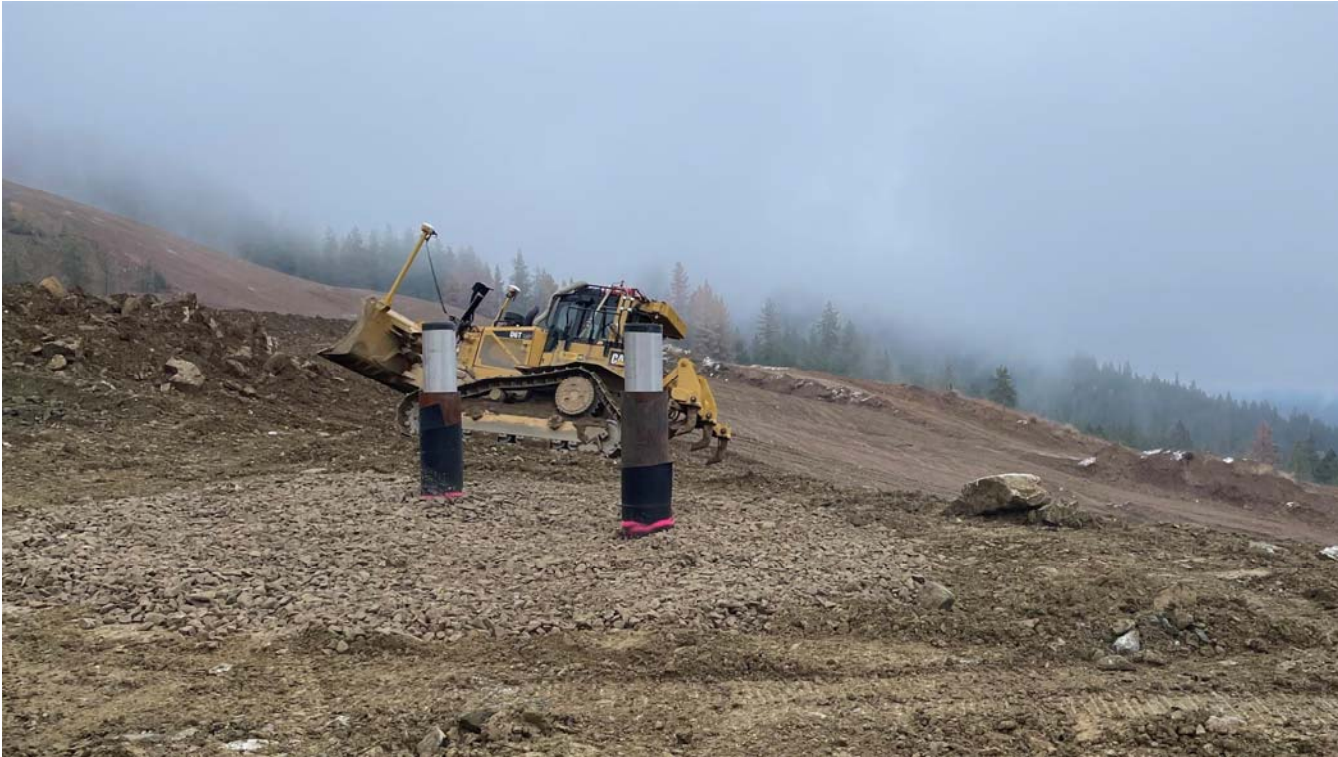
Figure 4 – Placing drain gravel around the dewatering risers view looking northeast.
